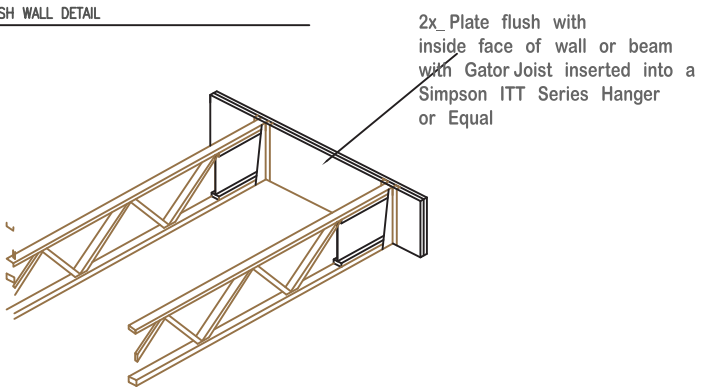
G FLUSH WALL DETAIL

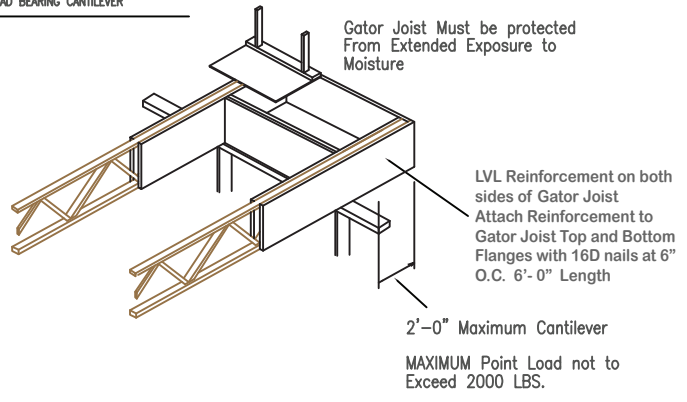
H LOAD BEARING CANTILEVER

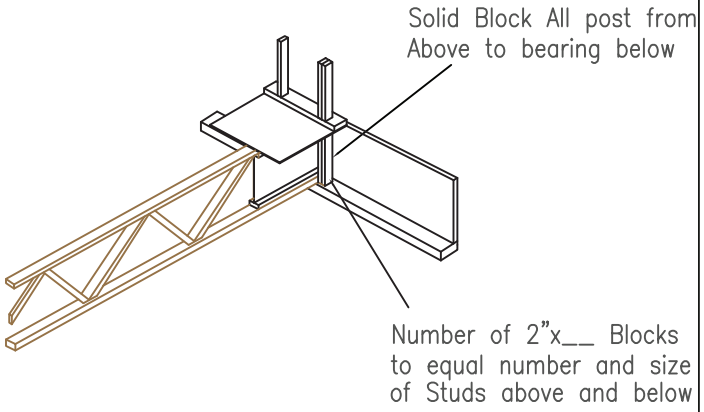
J EXCESSIVE LOAD TRANSFER 4400# +

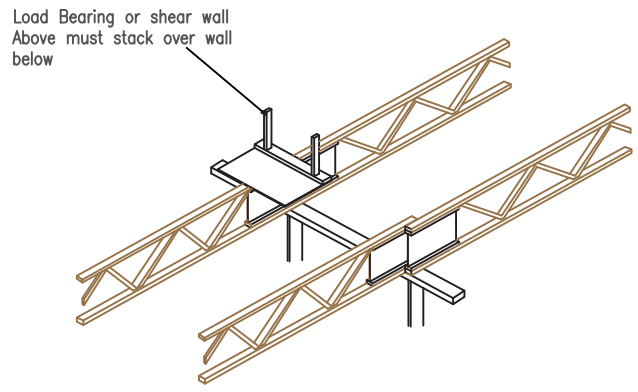
K OVERLAP DETAIL AT INTERIOR BEARING

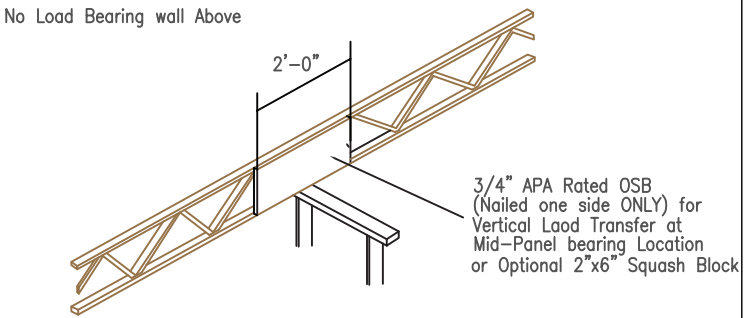
L INTERIOR BEARING CONDITION

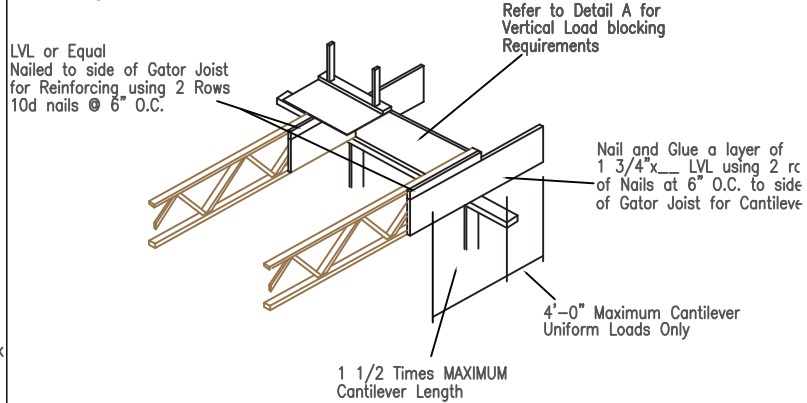
M DROP BALCONY WITH CANTILEVER

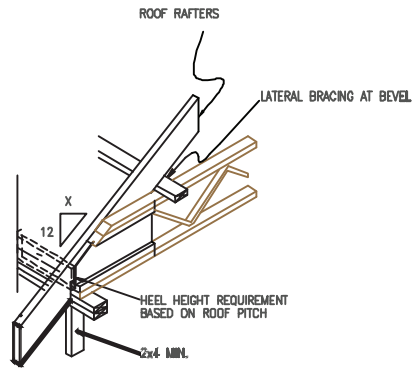
RC RAFTER CUT DETAIL

MINIMUM HEEL HEIGHT	MINIMUM ROOF PITCH	ANGLE IN DEGREES
4 1/4"	12	45°
6 9/16"	10	40°
7 15/16"	9	36.75°
9 1/8"	8	33.75°
10 3/8"	7	30.25°
11 9/16"	6	26.5°
